# **Navajo Abandoned Uranium Mine**

## **Site Screen Report**

### **Cottonwood Butte AUM Site**

**March 2010**

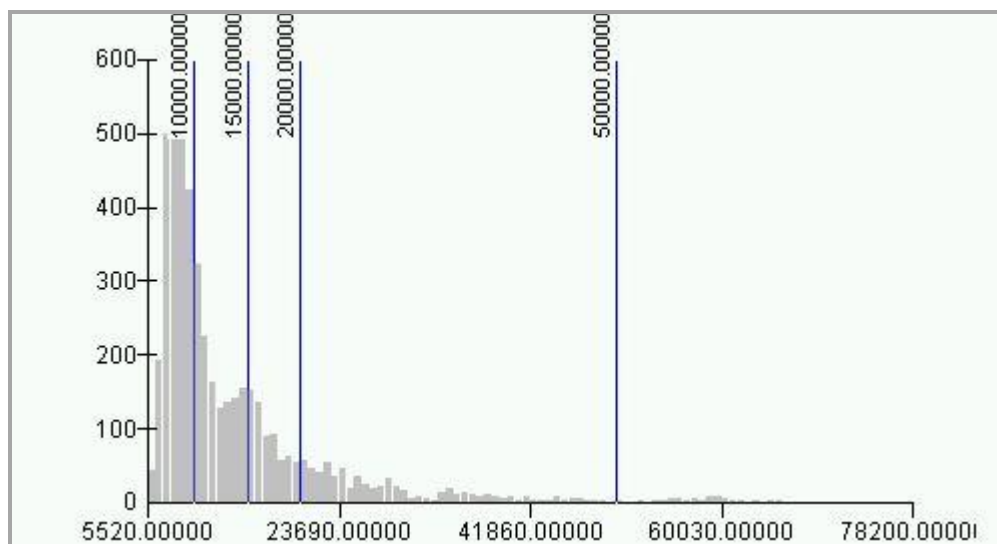
The following chart and statistics were generated by ESRI ArcGIS 9.3.1, and show the general distribution of the site gamma radiation measurements. The horizontal X axis represents the gamma radiation reading levels in cpm (lowest levels to the left). The vertical Y axis represents the frequency of each gamma radiation level.

Count:	4859
Minimum:	5520.00000
Maximum:	78200.00000
Sum:	67177535.00000
Mean:	13825.38279
Median:	10344.00000
Standard Deviation:	9260.93429

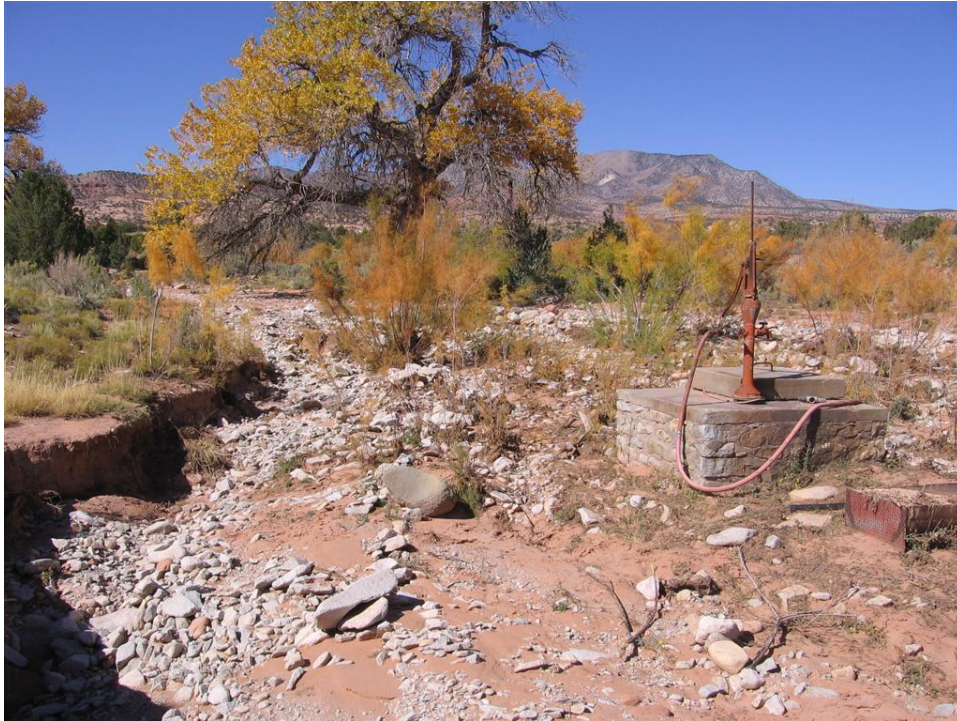
Photo 1. Livestock well approximately 0.3 miles east of mine site

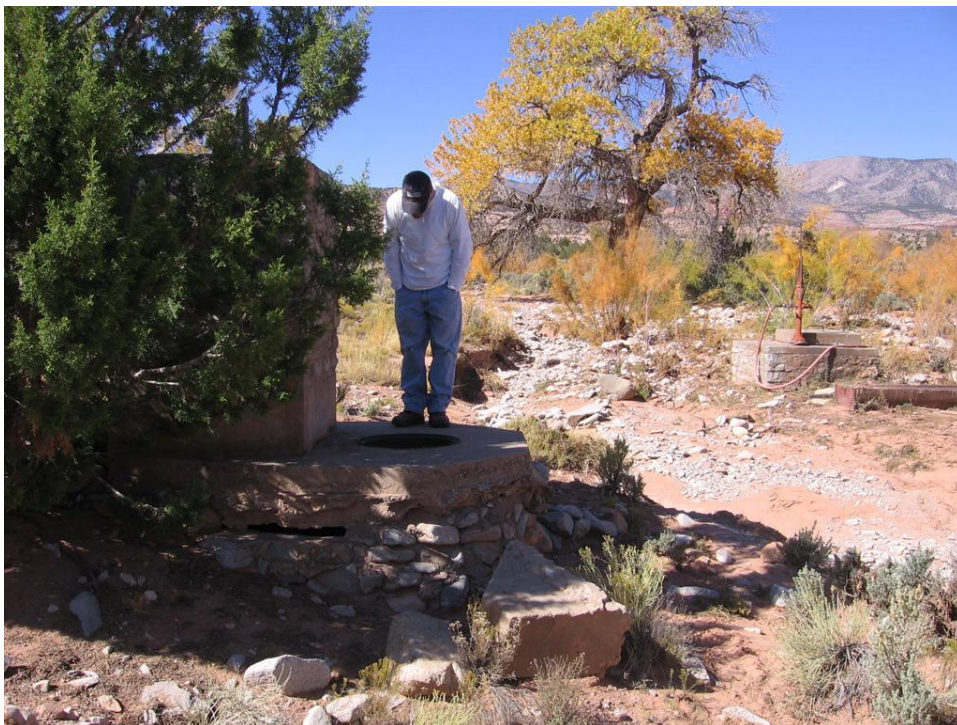
Photo 2. Livestock well approximately 0.3 miles east of mine site

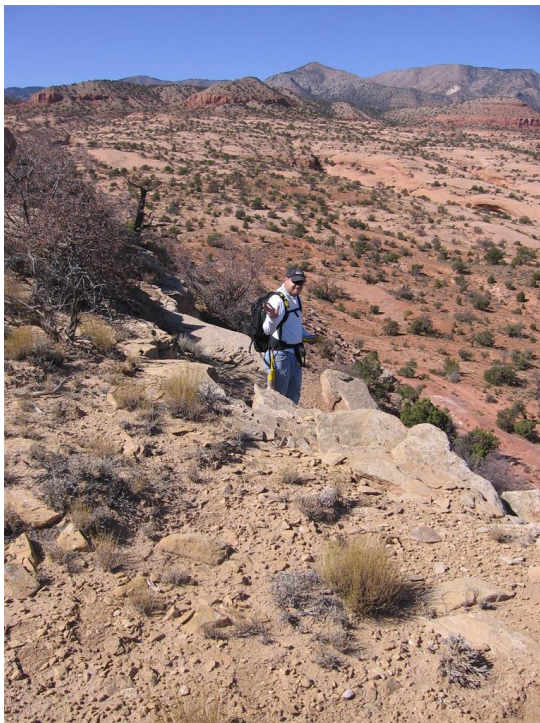
Photo 3. Mine site down slope area

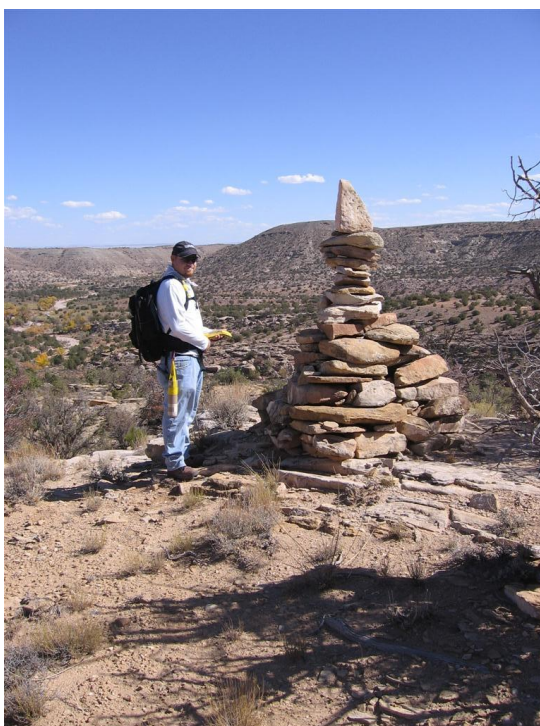
Sealed adit with stacked stone monument

Photo 4. Stacked rock marking adit location

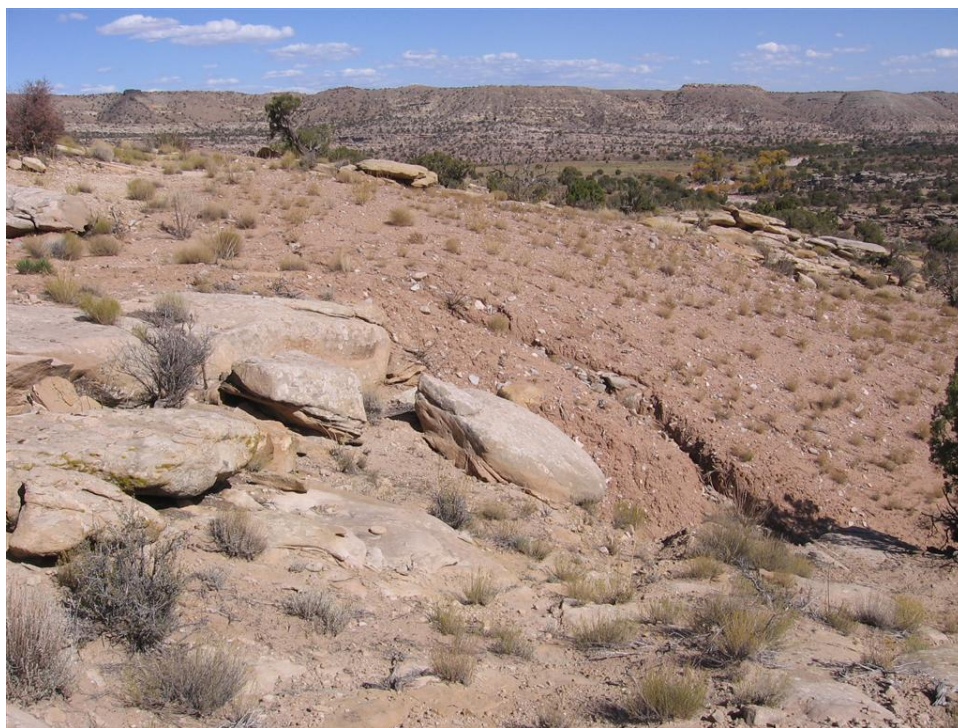
Possible reclamation cap, 20' x 60', red clay mixed with waste rock

**Is the cap/seal functionally intact?** Yes

**Is the cap/seal sufficiently degraded to create a concern about releases?** No

Photo 5. Clay reclamation cap

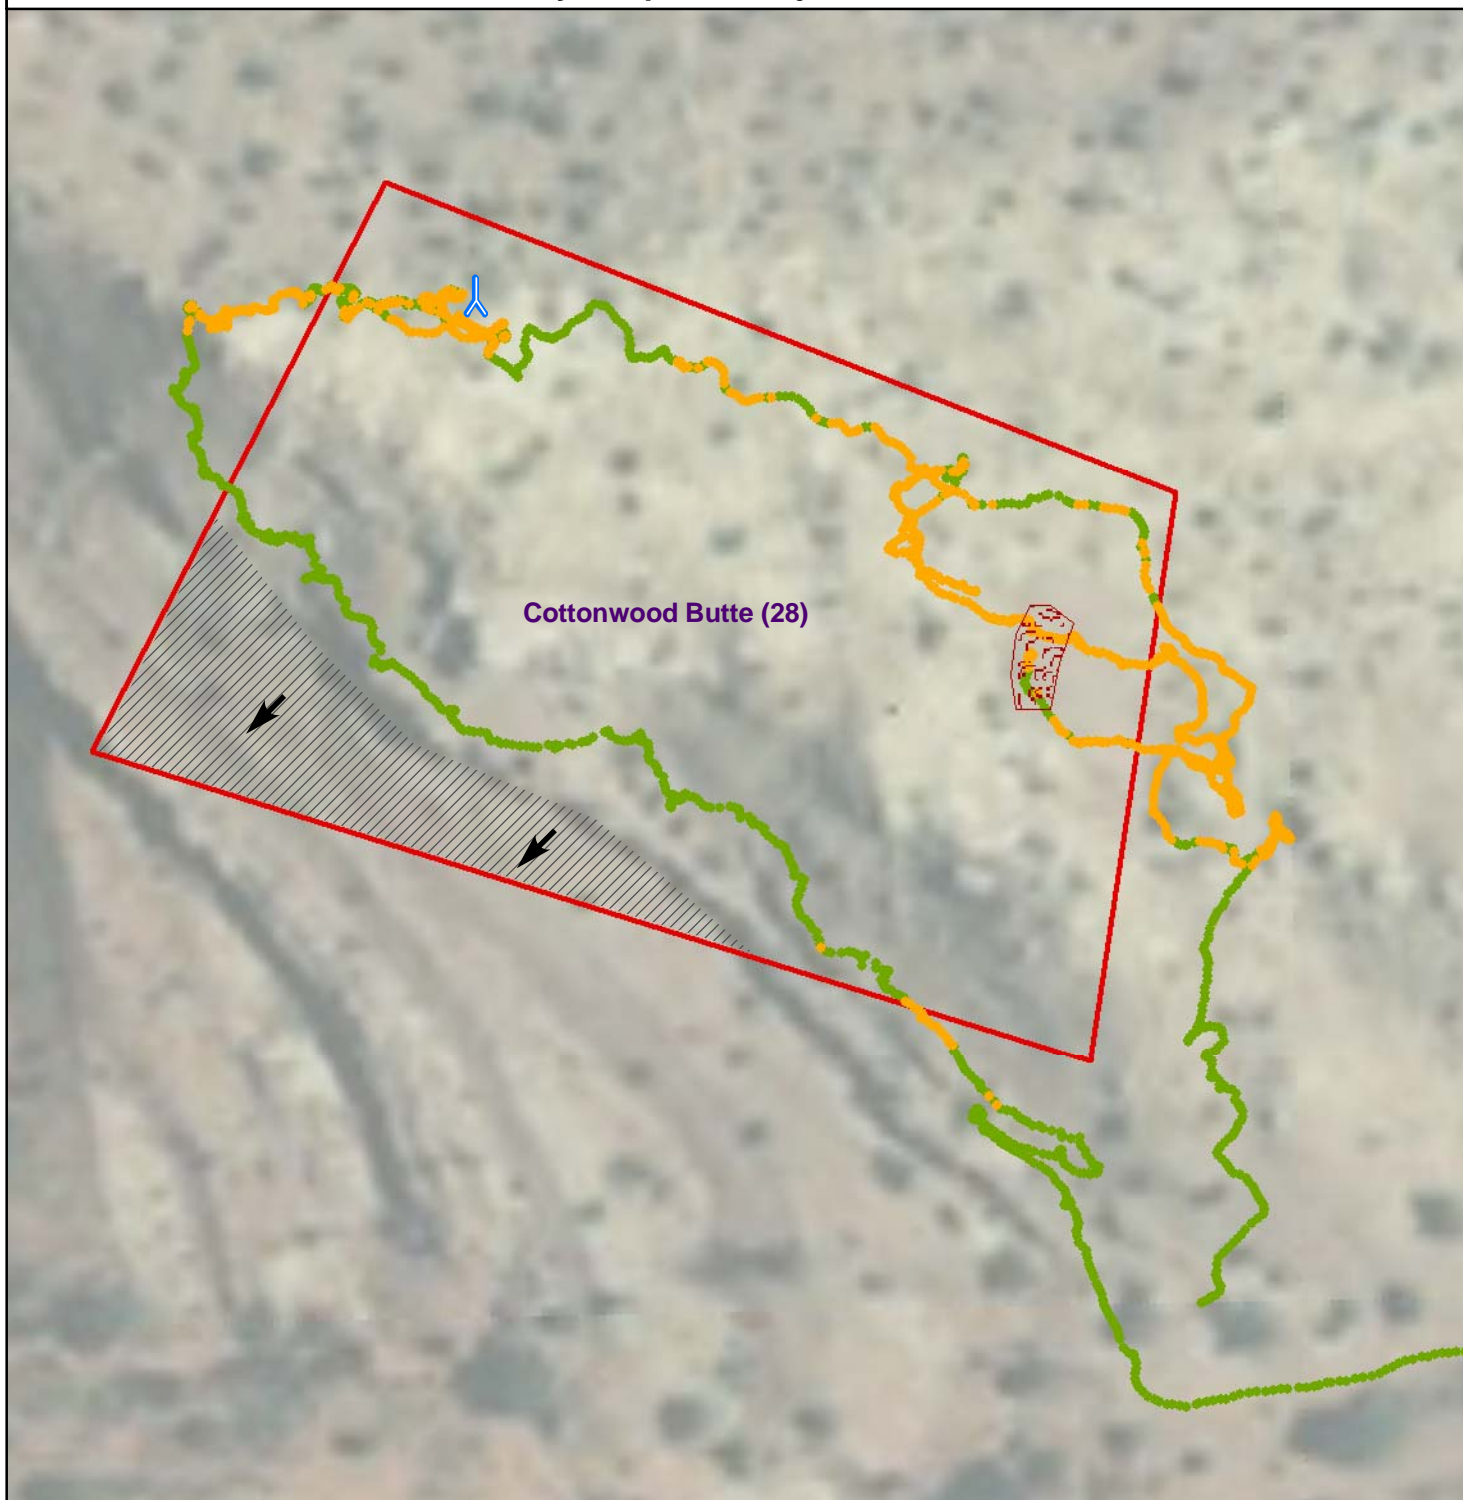
A total of 4,859 gamma radiation measurements were collected from the mine site, ranging from 5,552 cpm to 78,200 cpm. Measurements in the vicinity of the reclamation cap were found at levels above 65,000 cpm. The measurements are represented in Figures 1 and 2.

**Figure 1 - Gamma Radiation Measurements, Above Two Times Background  
Cottonwood Butte Mine (28)  
Red Valley Chapter, Navajo Nation, Arizona**

Gamma survey conducted 10/2009  
Measured as counts per minute (cpm)

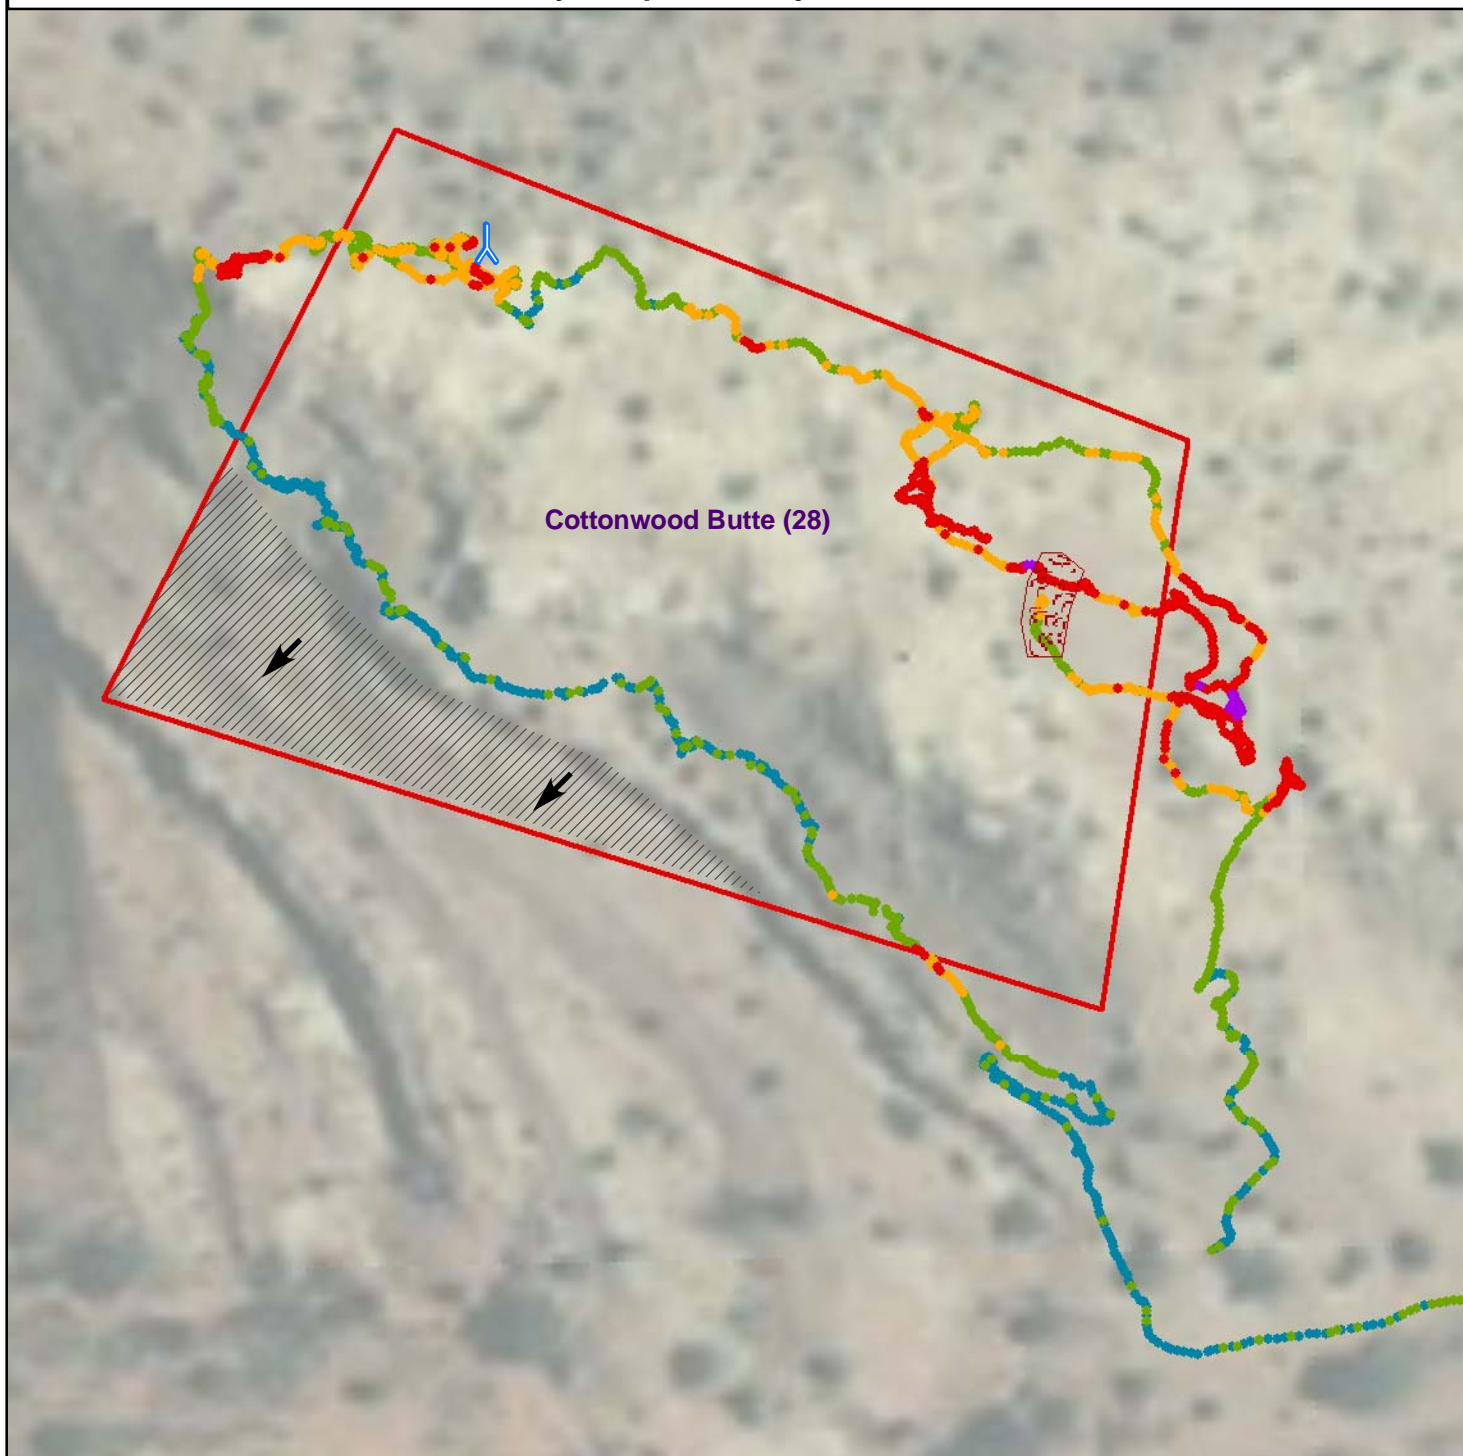
**Figure 2 - Gamma Radiation Measurements  
Cottonwood Butte Mine (28)  
Red Valley Chapter, Navajo Nation, Arizona**

Gamma survey conducted 10/2009  
Measured as counts per minute (cpm)
